Achieving better safety and health in construction  
Information report

European Agency  
for Safety and Health  
at Work

Luxembourg: Office for Official Publications of the European Communities, 2004

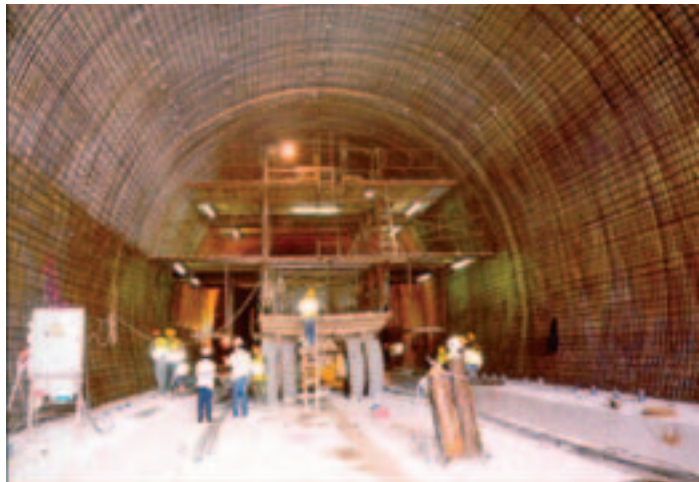
*The tunnel in Dodoni Reinforcement positioning in tunnel*

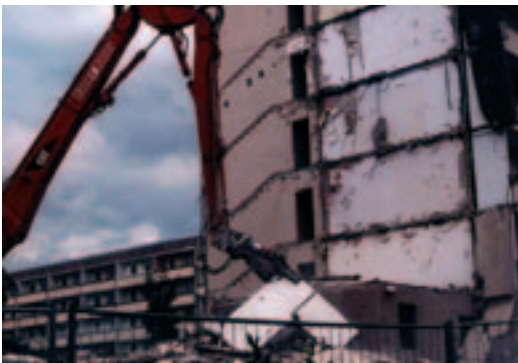
*Cautious removal with a gripper-like demolition tool*

The prefabricated standard buildings are connected by blocks 15 to 20 m high (between five and six storeys), a width of 10 to 15 m and a varying length of around 20 to 200 m. The standardised elements are connected by reinforcement iron.

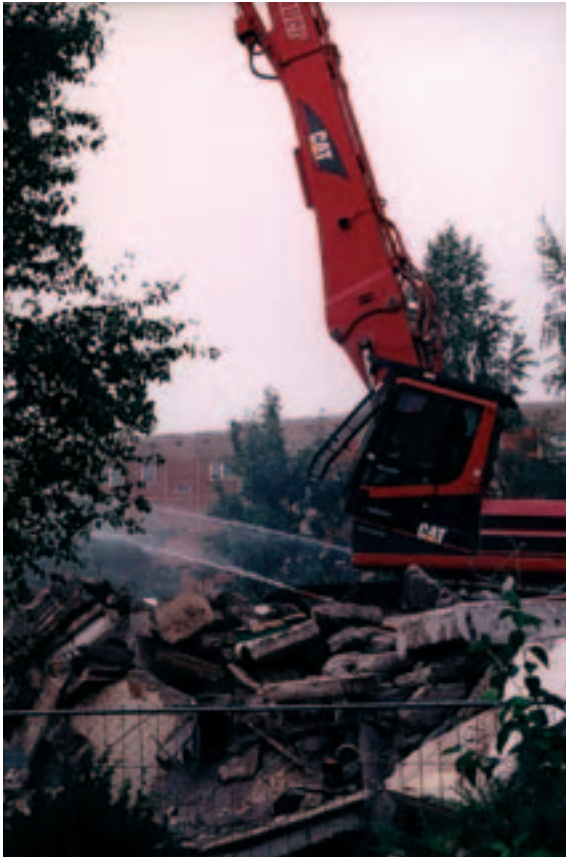
Watering of the working area to reduce the emission of dust and fibres

The labour inspection controlled the number of fibres during demolition work in the air by measurement. The average number of fibres was around 25 % of the threshold limit value.

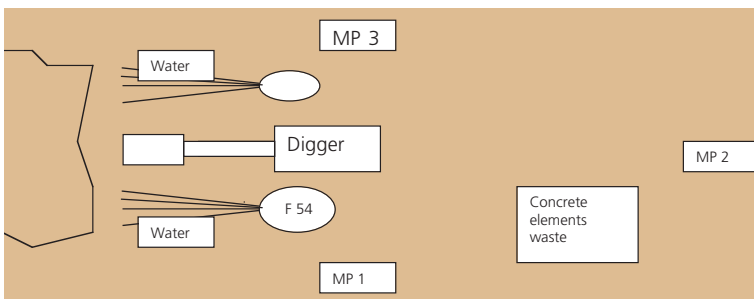
Position of the measuring points

Measuring points	Average concentration in F/m <sup>3</sup>	Threshold limit valueF/m <sup>3</sup>
MP 1 one 15 m from outer wall	91 182	500 000
MP 2 one 30 m from outer wall	40 851	500 000
MP 3 one 15 m from outer wall	89 694	500 000
F 54 Personal sampler watering work	140 607	500 000

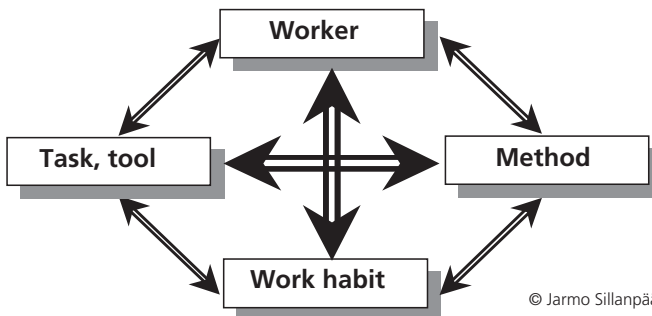
Figure 1. Worker-task system

In the worker-task system (Figure 1) all elements should be in good shape. Workers' knowledge and skills may be adequate, work methods proper, and

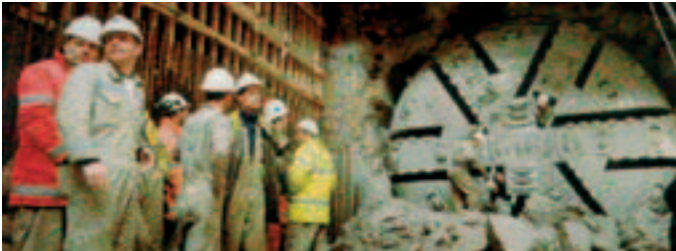
*The tunnel-boring machine*

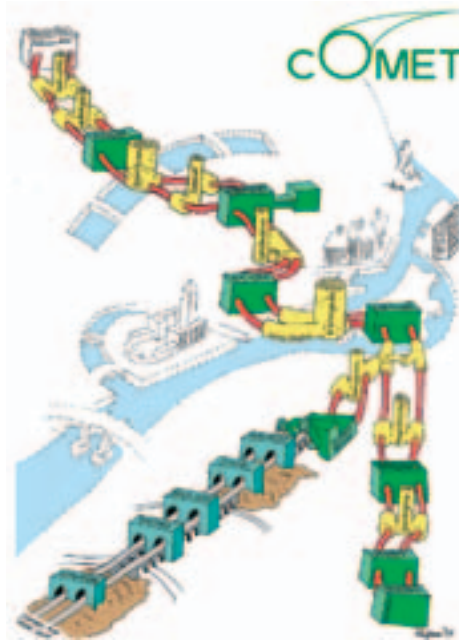
Figure 1: Illustration of the Copenhagen metro

Figure 1 shows the Copenhagen metro line, stations, ventilations/emergency shafts in phases 1 and 2A, which is currently in operation. Beside this there is a phase 2B (running mainly in the Frederiksberg municipality). Phase 3 will be built in the period 2003–07.

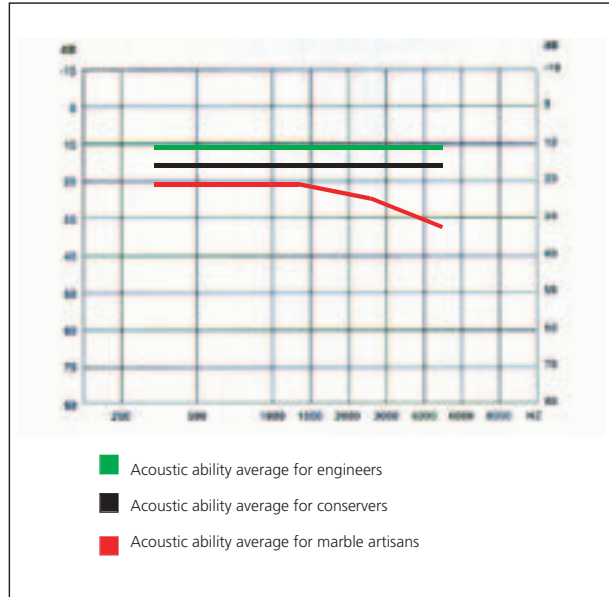
Figure 1: Audiometry curves representing the acoustic ability of the groups of engineers, conservers and marble artisans

With regards to the medical examination those workers with significant reduction in their acoustic ability (proportional to years of exposure) were the marble artisans. In Figure1 we can conclude that the group of marble artisans presents a significant reduction in acoustic ability in 2000 and 4000 Hz. The normal acoustic ability is around 0–10 dB.

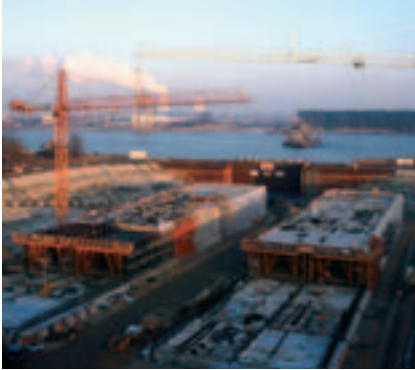
*Prefabrication of two tunnel elements in the dock beside the river (courtesy of Heinrich Hirdes GmbH)*

When two elements were ready, the lock was opened and the dock area was flooded. The tunnel elements could be transferred to the river and stored until all elements were ready.

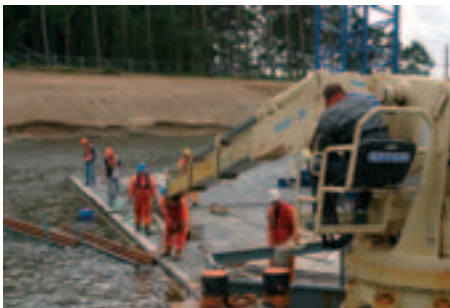
*Immersion of the tunnel elements (courtesy of Heinrich Hirdes GmbH)*

Divers were necessary for certain specialist works, such as unlocking the dock, fixing the floating reclamation pipelines at the pipelines in the tunnel elements, controlling the positioning of the connection between tunnel elements, etc.

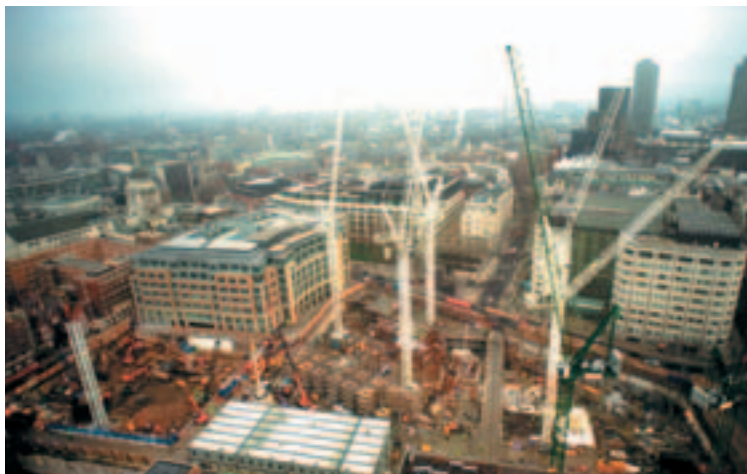
The steel beams, such as the one involved in this accident, had been specified with pre-drilled holes. This was to enable lifting shackles to be fitted through the holes and enable them to be lifted without the need for chain slings to be wrapped around the beams. This made the lifting operation easier, and consequentially safer. Hence health and safety had been 'designed in'.

However, the steel beam that was dropped was delivered with no pre-drilled holes. The resultant lift was carried out using chain slings alone. The beam slipped out of the slings and fell to the ground. This would not have happened had the beam been pre-drilled, and lifting shackles used.

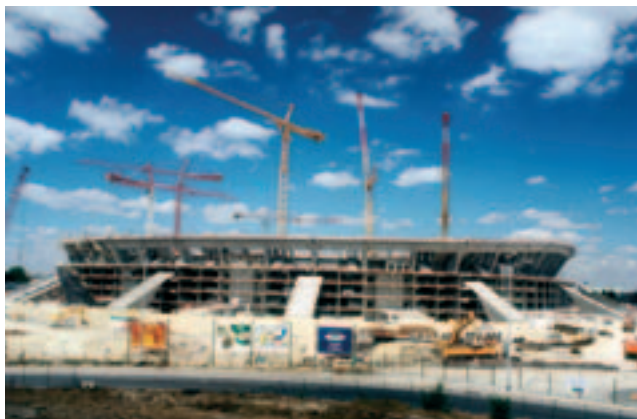
- under the roof covering ('velum') by cradle;
- in the roofing ('plenum');
- on the extrados of the roof ('tectum').

The flow of people going to their workstations at the roof level was organised in such a way as to give priority to protected routes. Likewise, the physical locking of roof access points is the principle adopted to avoid exposure to falls.

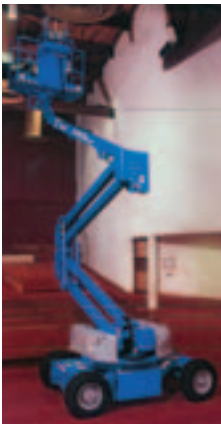
For work at heights, it is important to choose the temporary structure most appropriate for differences of level. These problems were faced above all in a few specific cases:

- installation of smoke detectors on the centreline of the ceiling in the main entrance, a hall over 9 m high and 2 m wide, with two levels of shelving placed along the walls. The furniture placed in the centre of the room was moved, then scaffolding was assembled to obtain access to the ceiling;
- installation of a smoke detector in the centre of the arch over the main stairway giving access to the first floor. The work had to be performed at a height of about 12 m above the ground floor, where the temporary structures were installed (aerial basket or other perfectly stable device);
- installation of anti-smoke and anti-heat systems above the stairway providing access to the second-floor offices: the temporary structure was adapted to the stairway steps, on which it was supported, to ensure perfect stability;

- installation of optical smoke detectors at a height of 10 m in the library's main hall: the scaffolding already provided for other works was used in this case.
